**COMPOSITE ACTION IN A STEEL GIRDER SPAN WITH PRECAST DECK PANELS:
THE I-81 BRIDGE OVER THE NEW RIVER IN RADFORD, VIRGINIA**

October 2003
VTRC 04-R4

Two parallel bridges carry I-81 north and south over the New River in southwest Virginia, near the city of Radford. The bridges are identical in design and have been in place since 1985. In recent years, a number of maintenance issues have been reported, primarily related to cracking of the cast-in-place topping over partial-depth precast deck panels.

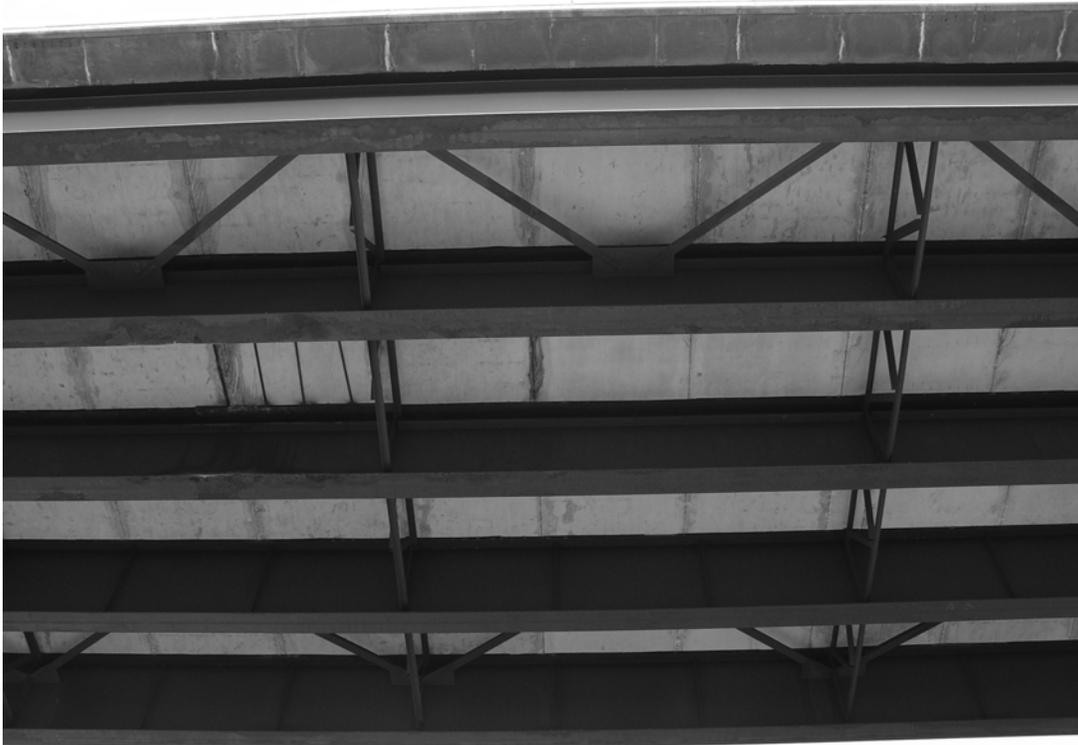
Figure 1. Underside of Precast Deck and Girder Supports System

Each of the parallel sister structures comprises 10 spans totaling 1,657.5 ft and 1,599.5 ft in length for the southbound lanes (SBLs) and northbound lanes (NBLs), respectively. Each structure carries two lanes of rural interstate traffic, with a large volume of heavy multi-axle trucks and tractor-trailers. Each structural span is composed of five haunched steel plate girders at 9-ft spacing, supporting a total deck width of 41 ft 11 in. The original design included continuous cast-in-place concrete decks. The order of placement was required to be upgrade, and epoxy sealing of construction joints was specified. During construction, substitution of partial-depth prestressed, precast deck panels with a cast-in-place wearing surface was permitted (see Figure 1). The panels were 8 ft wide by 8 ft long. The as-built prestressed slab thickness was documented as $3\frac{3}{4}$ in, with cast-in-place (CIP) concrete topping bringing the total slab thickness to approximately $8\frac{1}{2}$ in.

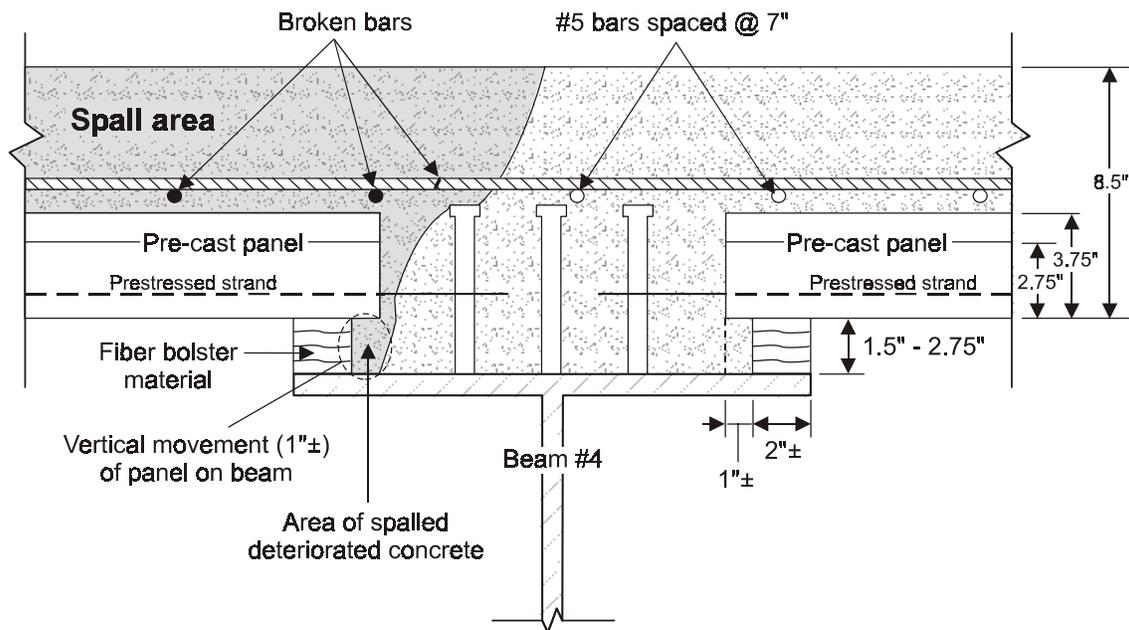
Figure 2. Schematic of As-Built Deck-to-Girder Interface

Figure 2 shows that the precast panels are bearing on a narrow strip of fiber bolster material along the outer edge of each top girder flange. Shear studs extend from the top face of the girder within the channel formed by the adjacent panels, and this space contains concrete, cast monolithically with the concrete topping layer above the panels. According to the field sketch, it appears that prestressing strands from the panels were not truncated at the face of the panel but were allowed to extend a short distance and were subsequently encapsulated in the CIP concrete.

A memorandum (Napier, 2000) indicates that where the edge of the panels bear on the fiberboard and CIP concrete, the panels do not extend beyond the fiberboard sufficient distance to provide permanent support. Napier states that the 1982 specifications (American Association of State Highway and Transportation Officials [AASHTO], 1977) under which the structure was built, and the as-built details of the structure, do not meet current recommended industry standards in this regard. Napier cites a 1987 memorandum from FHWA, which emphasizes, "the most significant detail for deck panels is to insure proper positive bearing of the deck panels on the beams" (Gordon, 1987). Napier's recommendations were to continue monitoring the structure, conduct dynamic load testing of the structure, and consider the viability of replacing the fiberboard with a more positive support material (Napier, 2000).

1. *As a means of slowing the rate of deterioration, it might be possible to replace the fiber bolster material between the top flange of the girders and the precast panels with more rigid (and more supportive) steel shims and/or formed concrete, shotcrete, or dry-packed cement mortar.* This would increase the surface area at the perimeter of the panels where load is transferred to the girders. Since the steel/concrete fill would be rigid, whereas the fiber bolster material is compressible, vertical displacement of panel edges under truckloads would be reduced or eliminated and dynamic impact at these joints could be minimized.

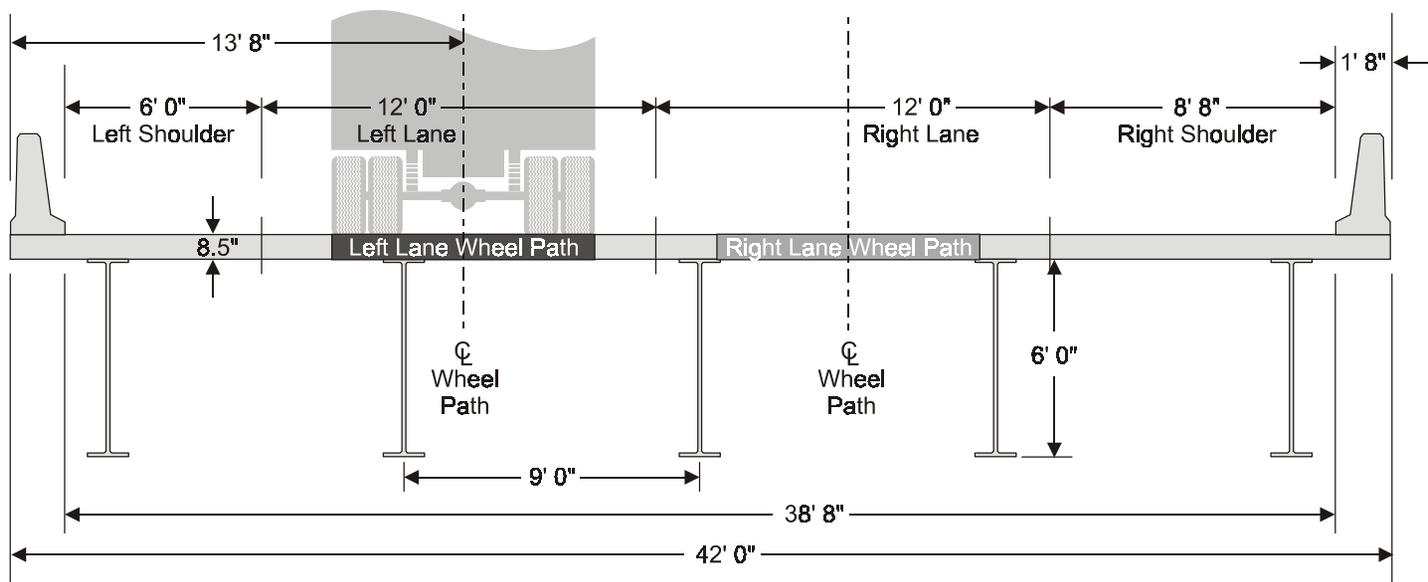
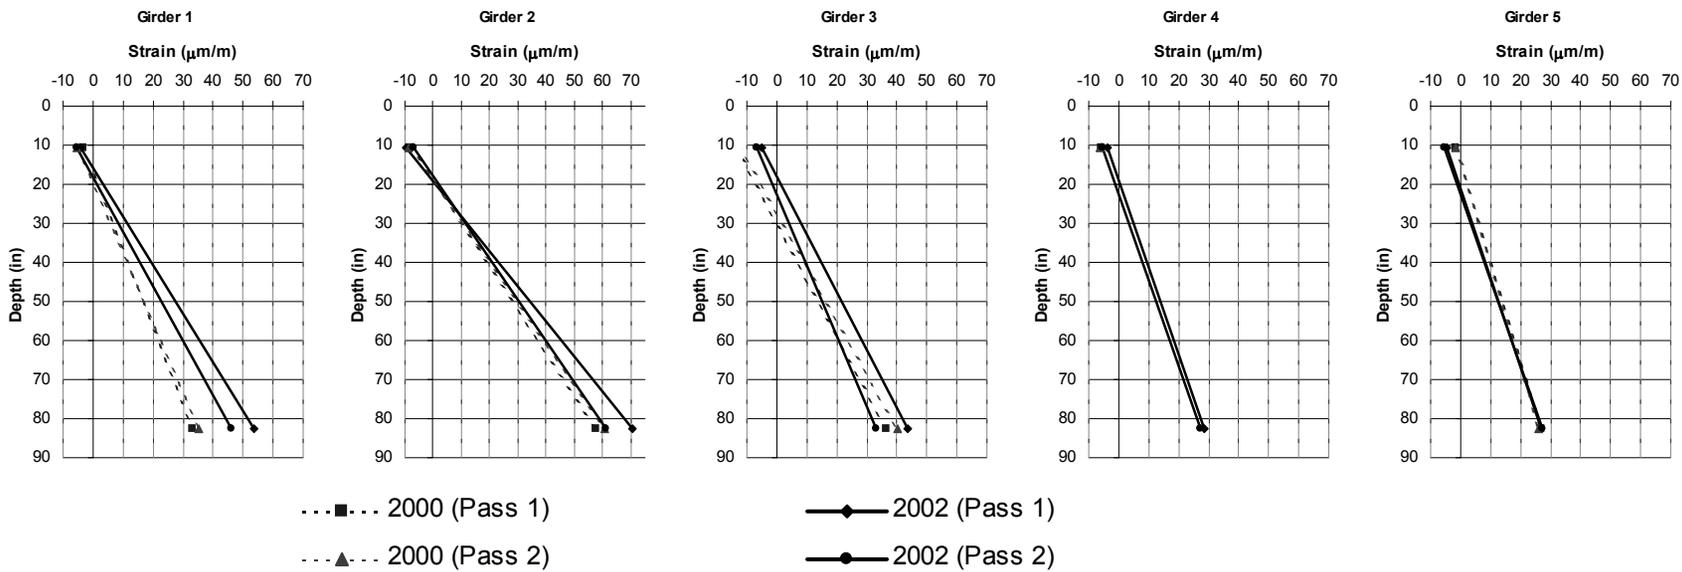
Figure 6. Comparison Strain Distributions by Girder Over Time: Left-Lane Passes

As shown in Figure 6, representing truck passes in the left lane, the strain in the bottom flange of Girder 1 was significantly higher during both passes in 2002 as compared to the two passes in 2000. A slight increase in bottom flange strain was also observed in Girder 2 over time. Strains in the other girders appeared essentially similar over time.

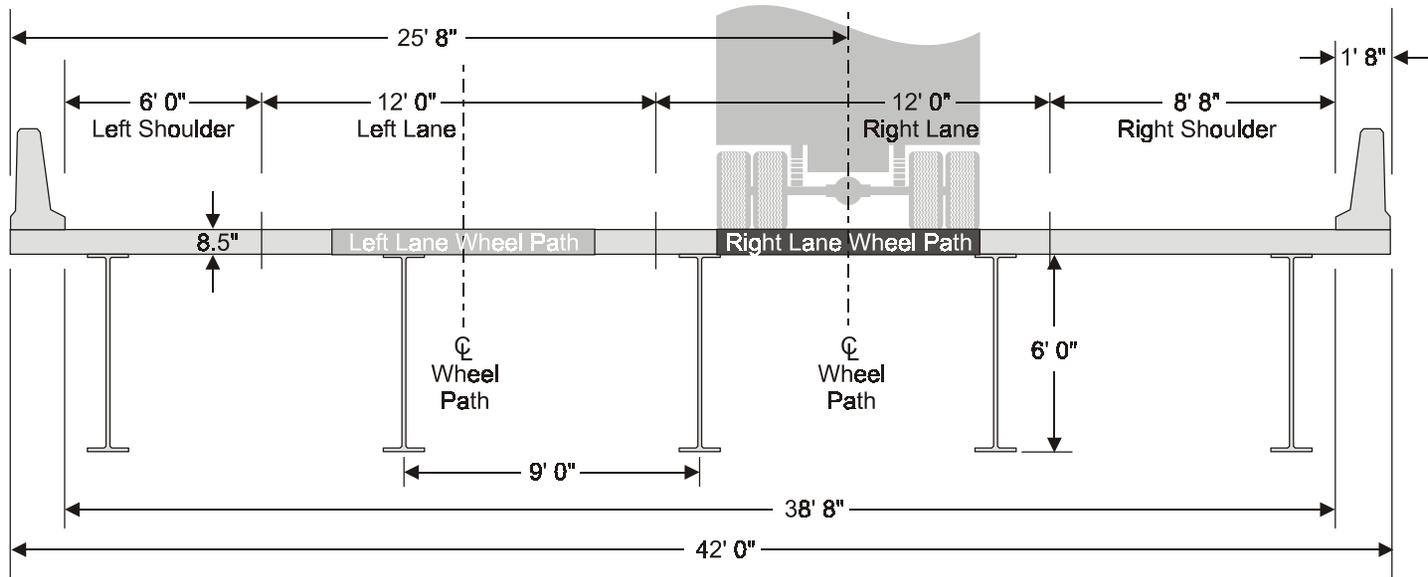
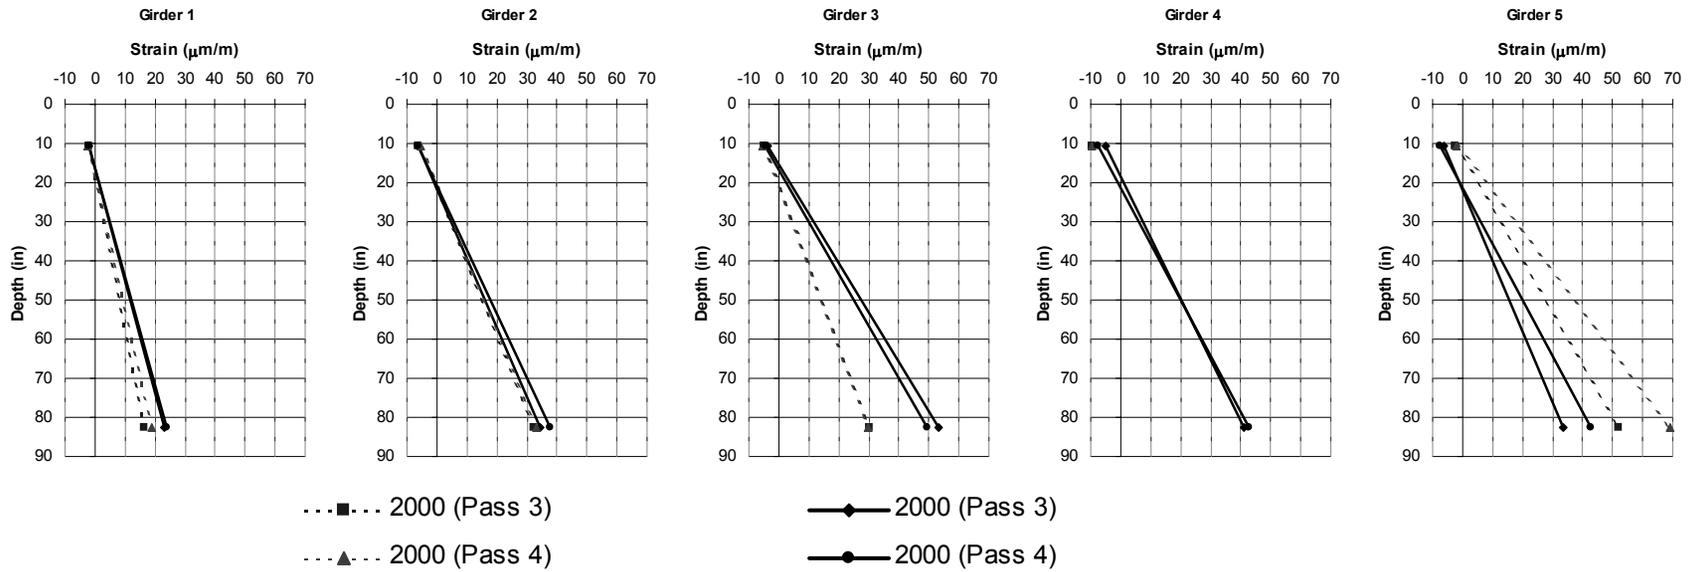
Figure 7. Comparison Strain Distributions by Girder Over Time: Right-Lane Passes

Figure 7, which represents right-lane truck passes, can be compared in the same manner. Girder 3 exhibited significantly greater strain in the lower flange in 2002 as compared to 2000. This might be interpreted as indicating a change in section properties for this slab-girder section. However, a reverse of this trend was observed in Girder 5, where the overall strain in the bottom flange was less in 2002 than in 2000. The wheel path outlined in Figure 7 is somewhat idealized, and the actual path of the truck will vary from one pass to the next. Thus, the increased strain in one girder and simultaneous decrease in another may be related more to the location of the passing truck relative to each of the girders at the two times of testing than to a change in section behavior. Therefore, simple comparisons of strain data are inadequate to assess the situation fully.

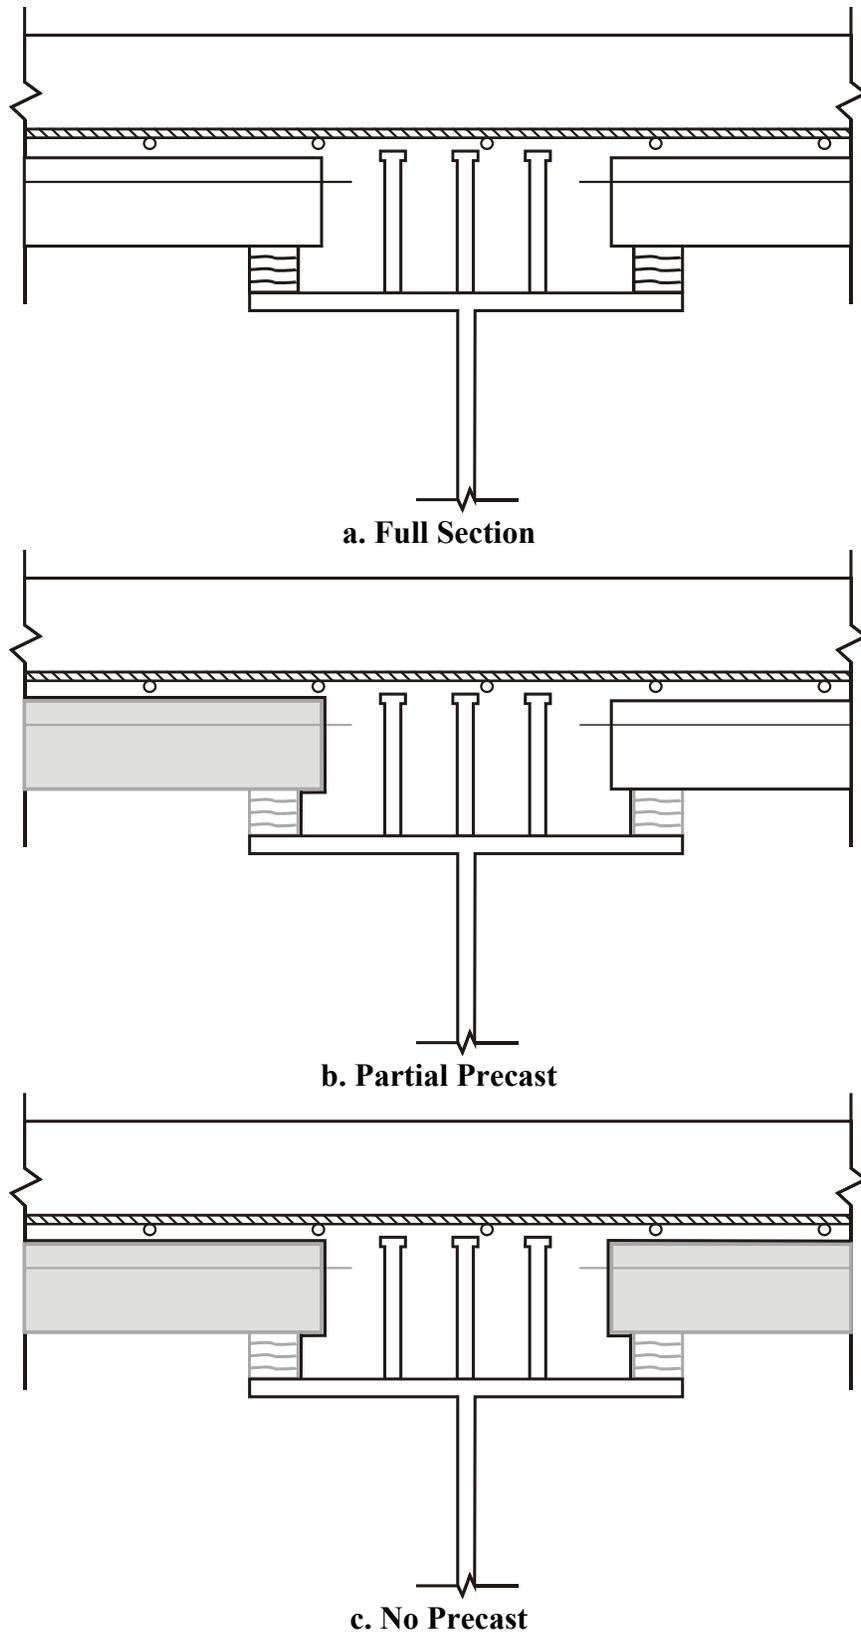
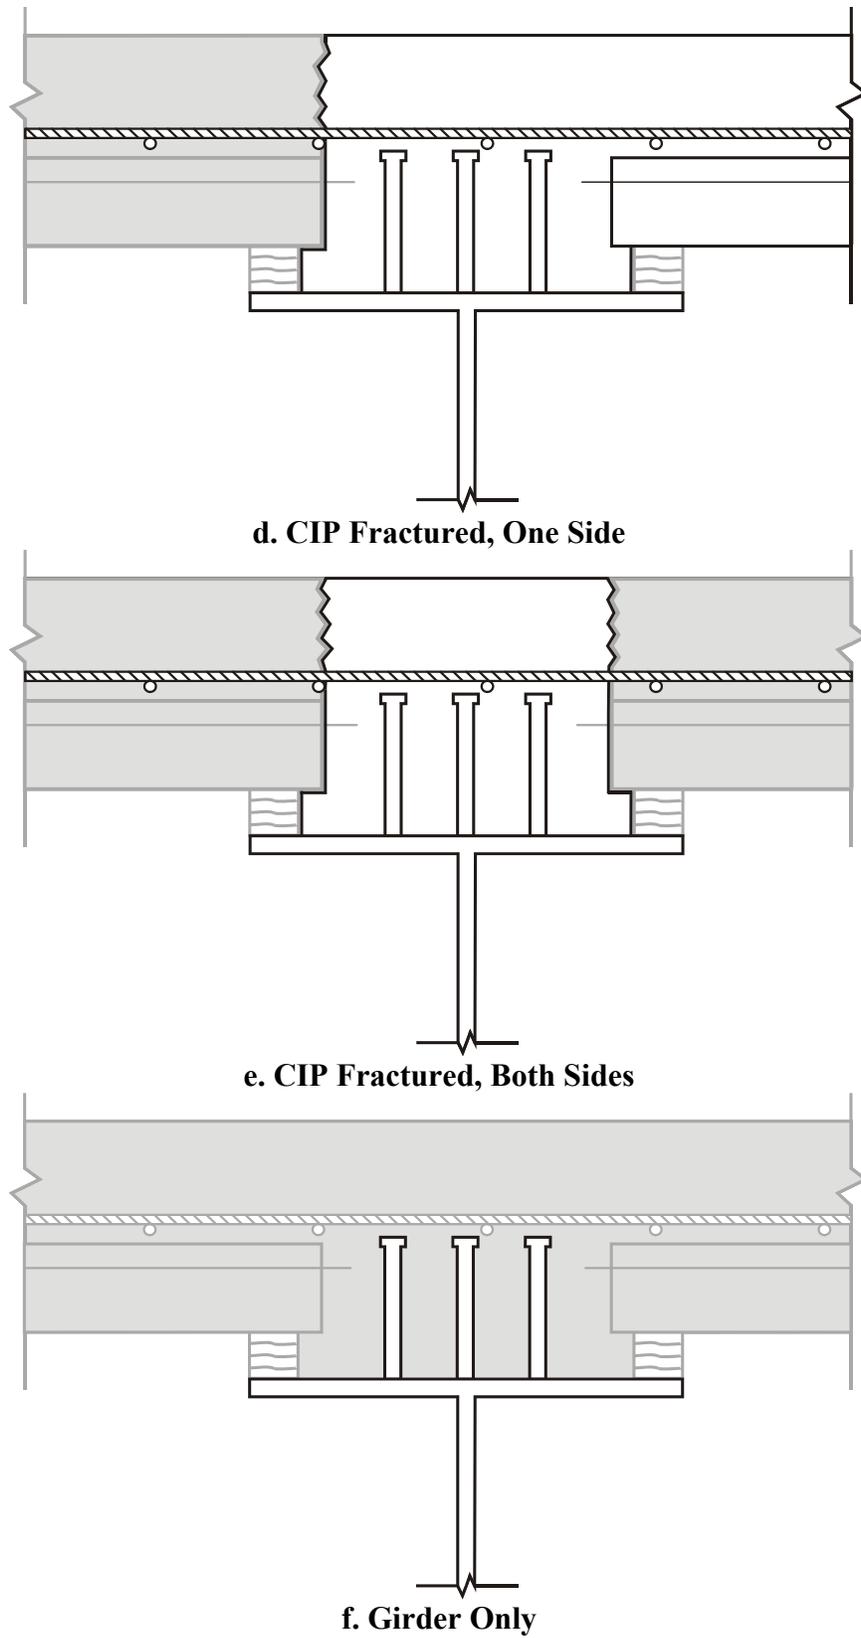
Figure 8. Degree of Composite Behavior between Girder and Precast/Cast-in-Place (CIP) Deck (*continues*)

To compare the observed strain data to an anticipated strain within the slab-girder section, several scenarios were considered, reflecting degrees of composite action, as shown in Figure 8. The first scenario (a) assumes complete interaction among the built-up steel girder, the precast panels on both sides, and the CIP concrete deck surface. Subsequent scenarios consider progressive loss of section performance through loss of bond with one or both precast panels (b and c, respectively), followed by fracture and loss of action of one or both side of the CIP concrete (d and e, respectively), and finally complete loss of load transfer to the deck (f).

The depth to NA was predicted based on the effective slab-girder cross section in each scenario. The progression of scenarios indicates that as composite action between the deck and the girder is reduced, the depth of the NA will increase. For the analysis, the concrete strength was assumed to be 4,500 psi on average, which translates to a modular ratio (E_s/E_c) of 7.6. Therefore, under ideal conditions, assuming an effective slab width of 108 in (equal to the girder spacing) and full composite behavior, the NA depth for an interior girder is calculated to be 9.1 in. Girders 1 and 5 are exterior girders, and the section properties have been calculated accordingly, assuming an effective slab width of 89.5 in and neglecting parapets. The resulting NA depth for exterior girders was predicted to be 11.1 in. In contrast, if the slab were assumed to contribute nothing to the capacity of the system, the NA for both interior and exterior girders would be expected to shift to 40.8 in depth.

Table 3 compares the NA depth for each girder, as determined in the tests, to the calculated NA depth for the various scenarios outlined previously. The calculations indicate that the average NA location is deeper than would be expected for a fully bonded composite system. In all cases, the average calculated NA depth was beneath the elevation of the slab, extending into the top of the girder. As shown in bold text, the NA depth is in the range more representative of partial or full loss of bond with the precast deck panels, or possibly some fracture of the CIP concrete topping. Although these results do not definitively confirm the loss of composite action between the deck and girders, they do suggest that the contribution of the deck to overall structural capacity is less than anticipated. However, for each girder, sufficient continuity remains between the components such that the girder is not carrying the full moment of the section.
